**STS-114  
PROGRAM FLIGHT  
READINESS REVIEW**

**ORBITER  
PROJECT (MV)**

**JUNE 29, 2005**

# **STS-114 PROGRAM FLIGHT READINESS REVIEW**

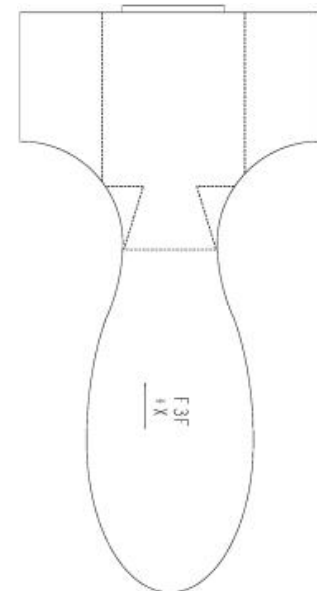
As-Installed  
(minus markings)

As-Cut  
Template

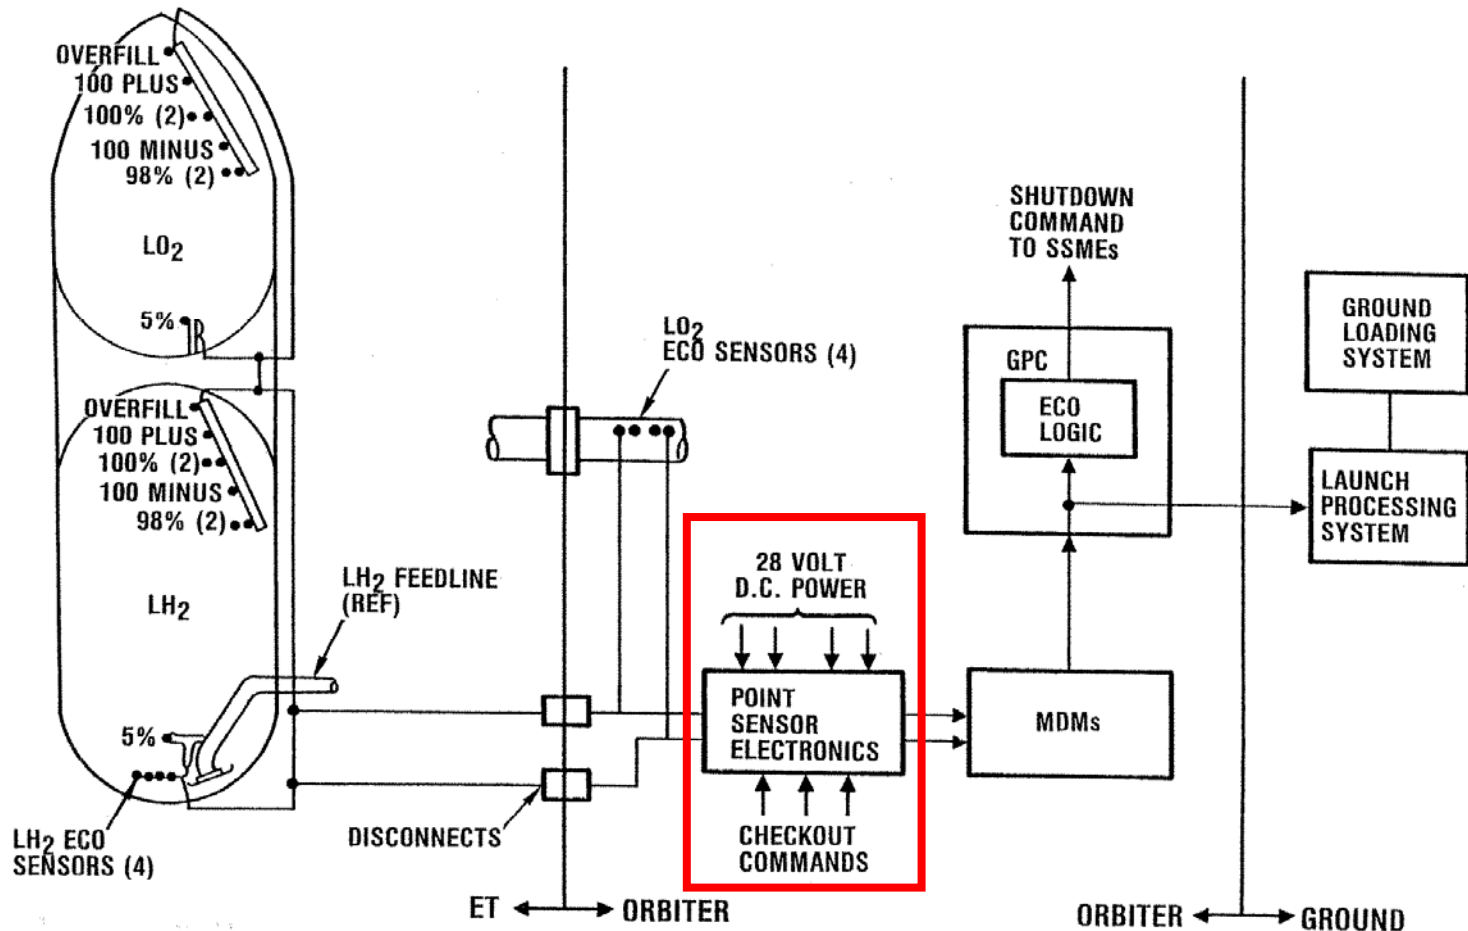
## Point Sensor Box and Sensor Overview

- LO<sub>2</sub> ECO sensors in the Orbiter 17 inch feedline
- Orbiter Point Sensor Electronics Box provides power and signal conditioning for ET and Orbiter point sensors

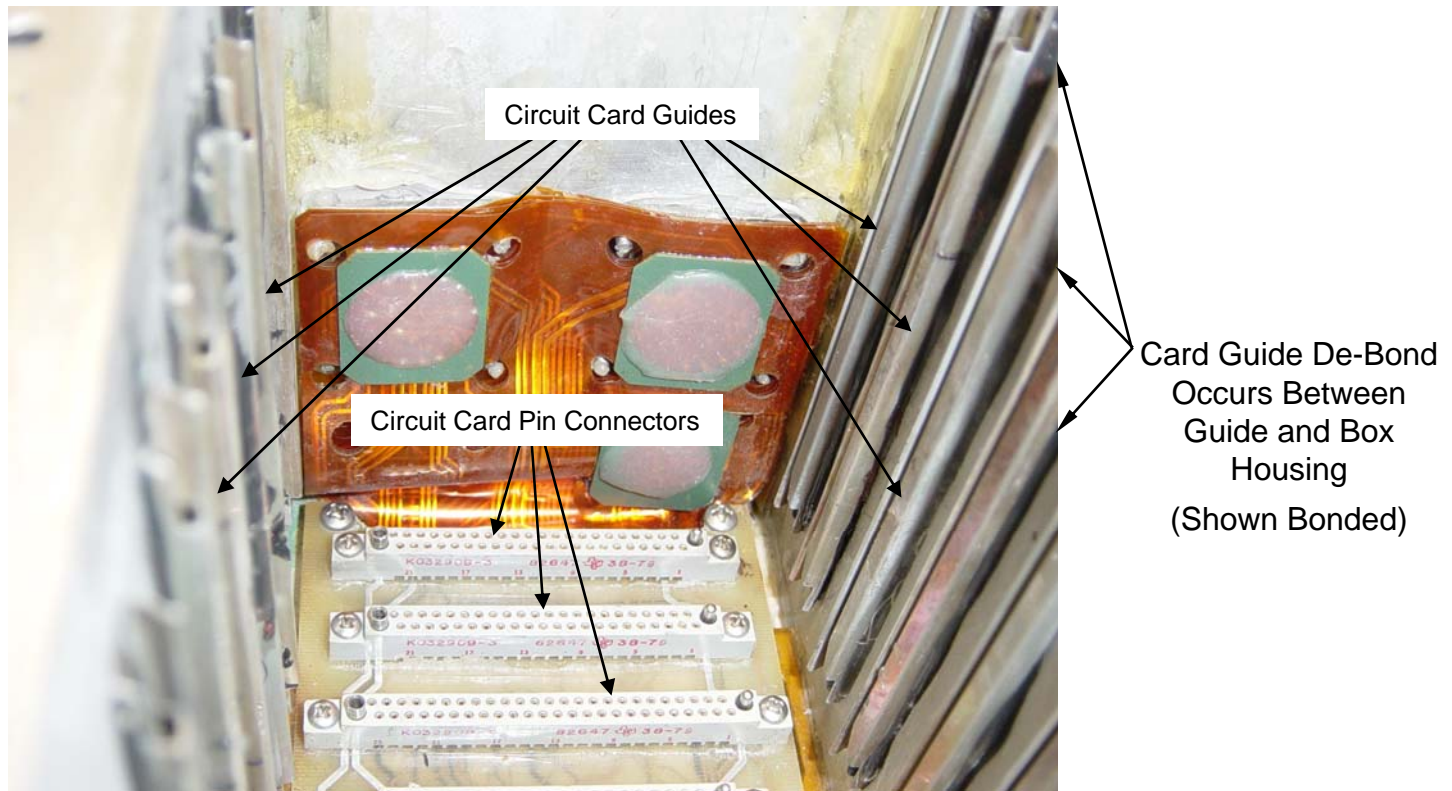
Point Sensor Box Interior (With Circuit Cards Removed)

- During TT&E of S/N 108, S/N 109, and S/N 110, some of the card guides found to be de-bonded from the side wall of the case
  - Similar findings expected if other boxes were opened
- Card guides provide both mechanical alignment with pin connectors, and a thermal conduction path to dissipate heat during operations
  - Two card guides per card, one on each side of the card
  - Even with guides de-bonded, cards are captured in place by pin connector on the bottom of the card and the top of the box - no concern for card movement or damage
    - Card guides are captured in place between the card and the side of the box
  - Potential concern relates to loss of thermal conduction capability due to de-bonding
    - Card guides remain in contact with the board, but not bonded to the side of the box

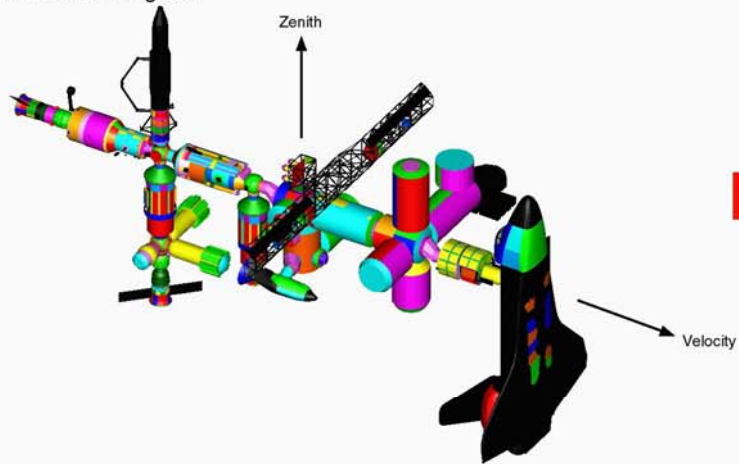
## Spacecraft Configuration (I-DEAS Finite Element Model)

- Describes spatial relationships of spacecraft components
- Defines spacecraft orientation (velocity and zenith directions)
- Defines M/OD shield regions

• Approximately 120,000 elements in ISS assembly complete mated configuration FEM

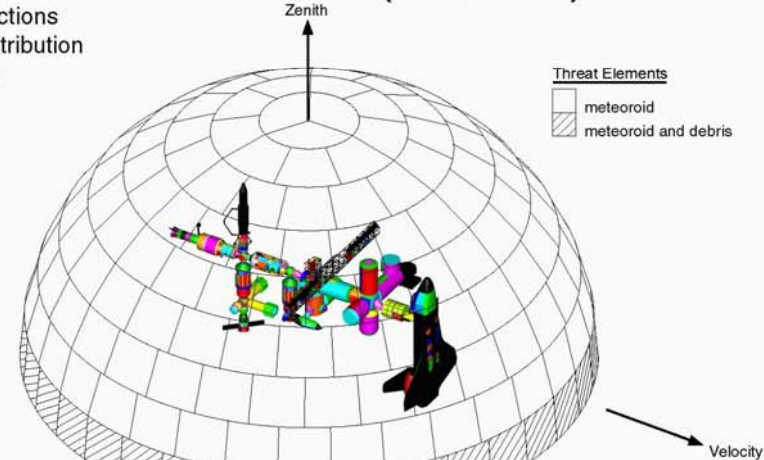
## Meteoroid & Debris Environments (GEOMETRY)

- Threat directions
- Velocity distribution
- Shadowing

- 90 debris threat cases and 149 meteoroid threat cases assessed for each element in the FEM

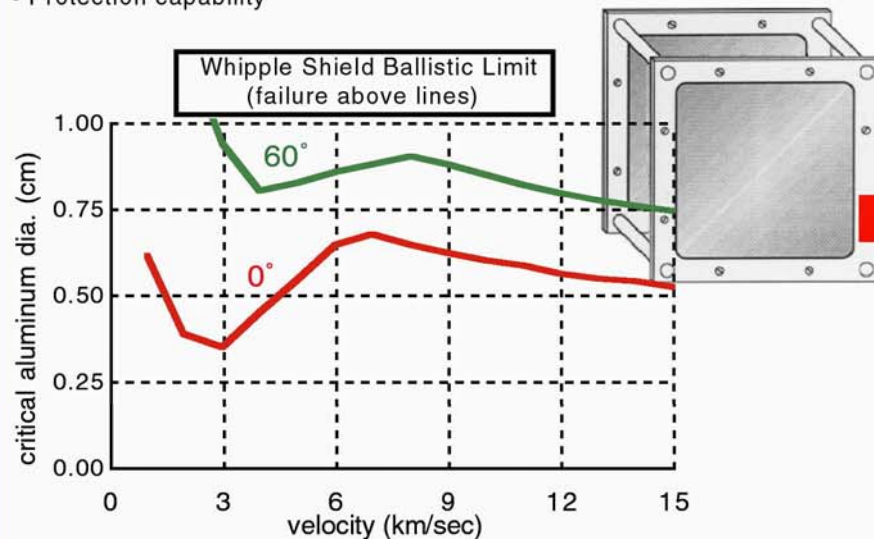
## Critical Particle Diameter Calculation (RESPONSE)

- Protection capability

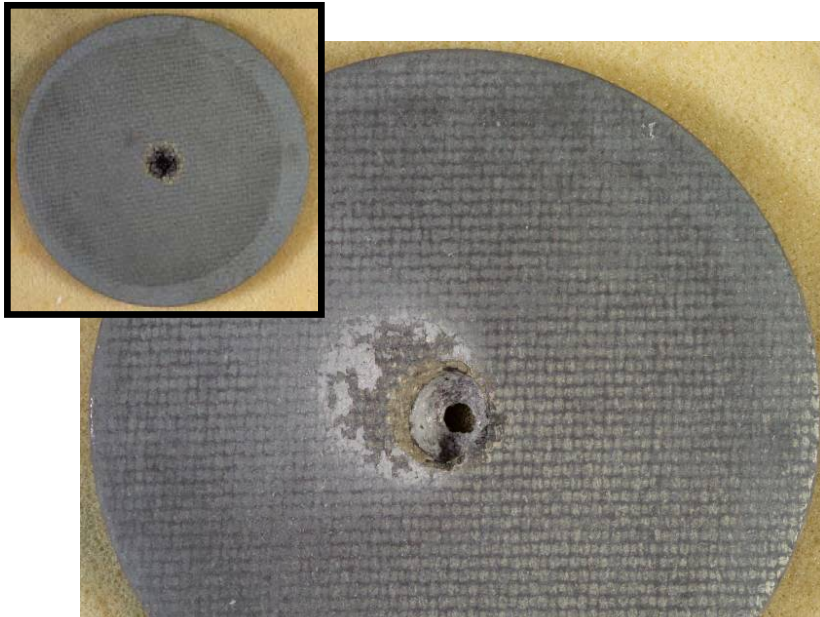
Hole develops at 830 s, but arrested by glass flow  
Final hole size 0.134" dia.

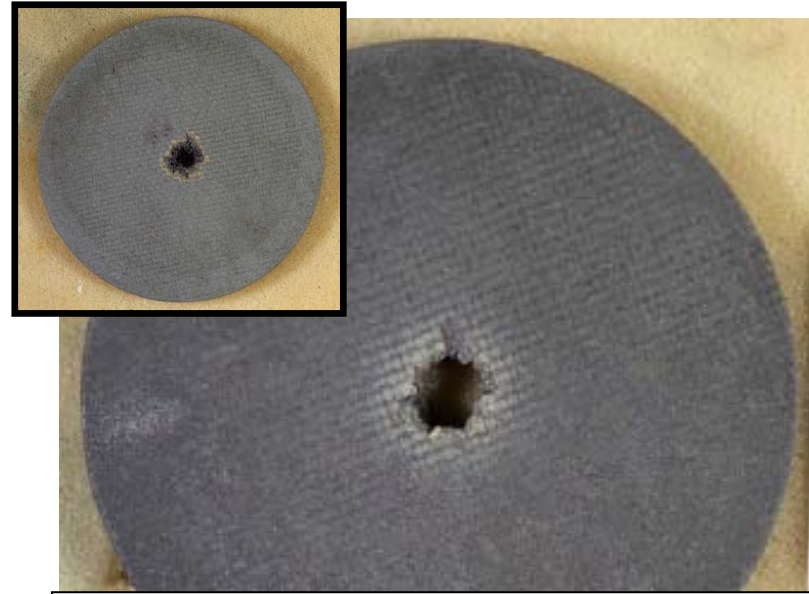
### Test #6

**2700F/ 98 psf**

0.26" dia. OML coating loss  
0.28" x 0.26" IML coating loss

Hole develops at 422 s, grows for remainder of run  
Final hole size 0.343" dia.

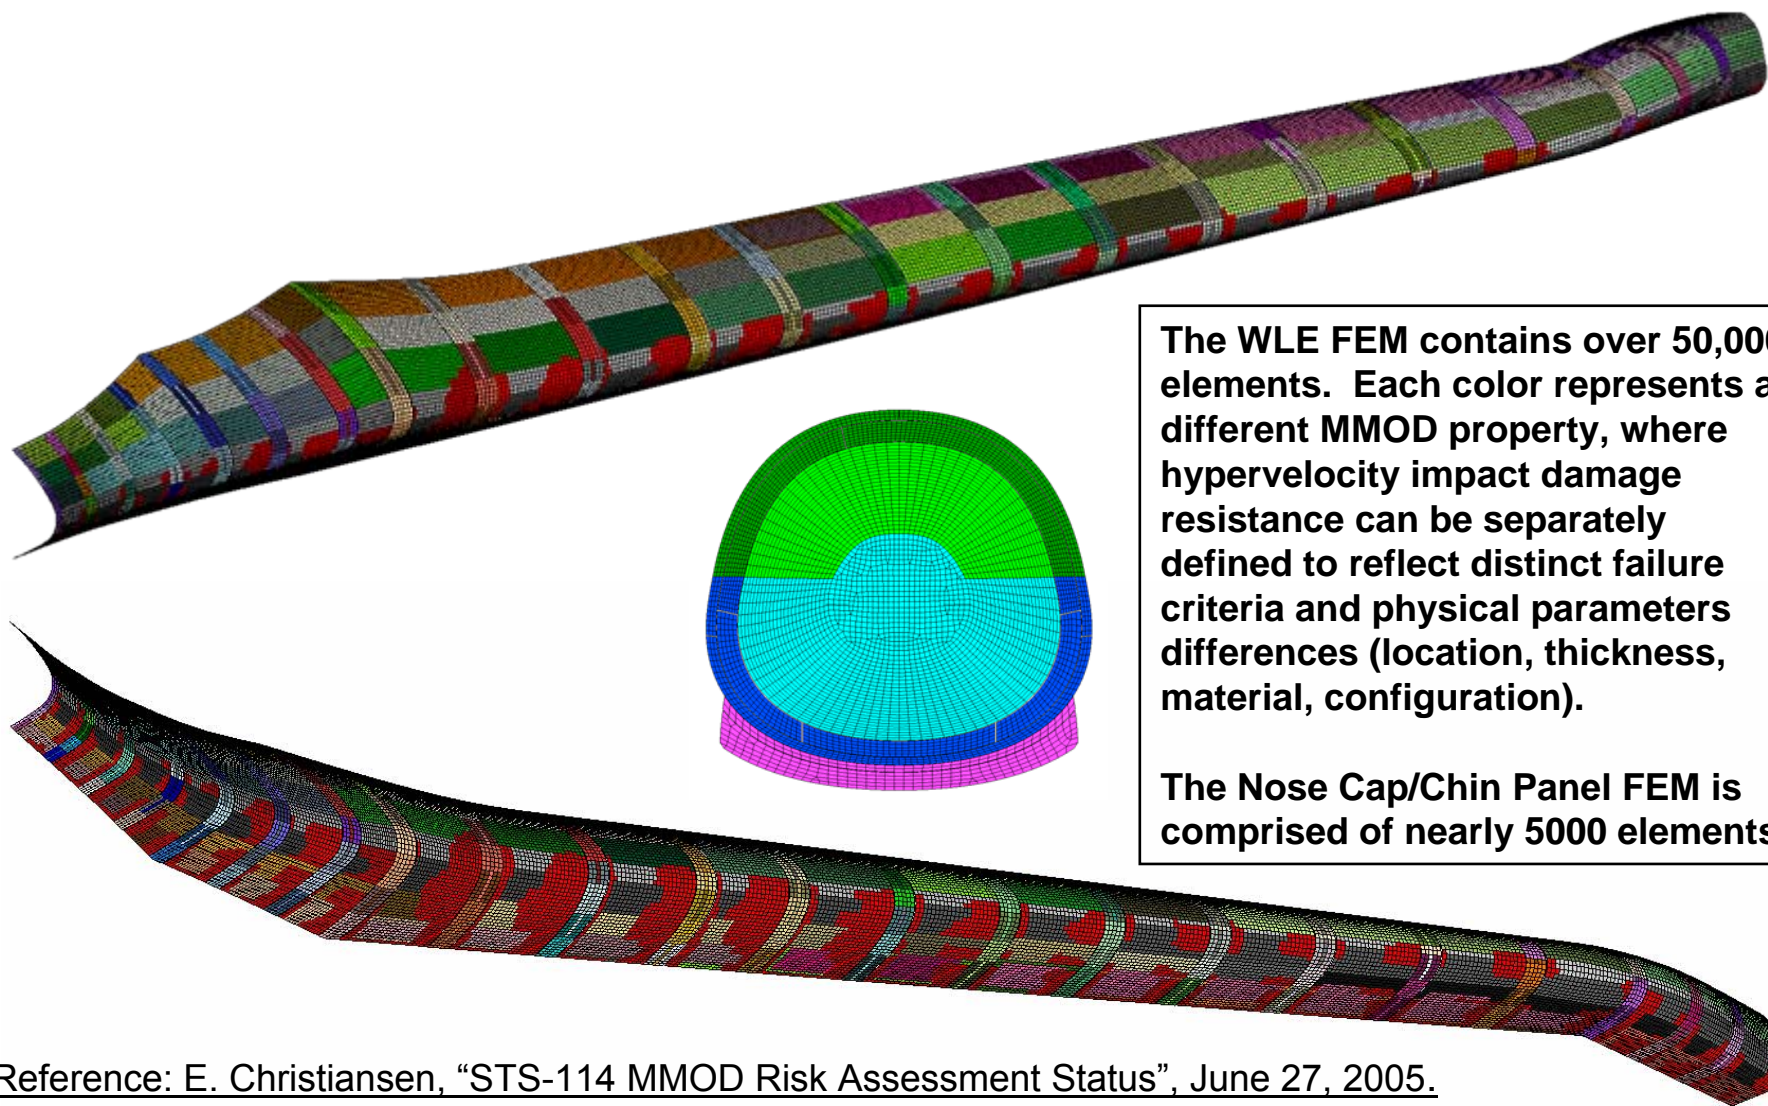
The WLE FEM contains over 50,000 elements. Each color represents a different MMOD property, where hypervelocity impact damage resistance can be separately defined to reflect distinct failure criteria and physical parameters differences (location, thickness, material, configuration).

The Nose Cap/Chin Panel FEM is comprised of nearly 5000 elements.

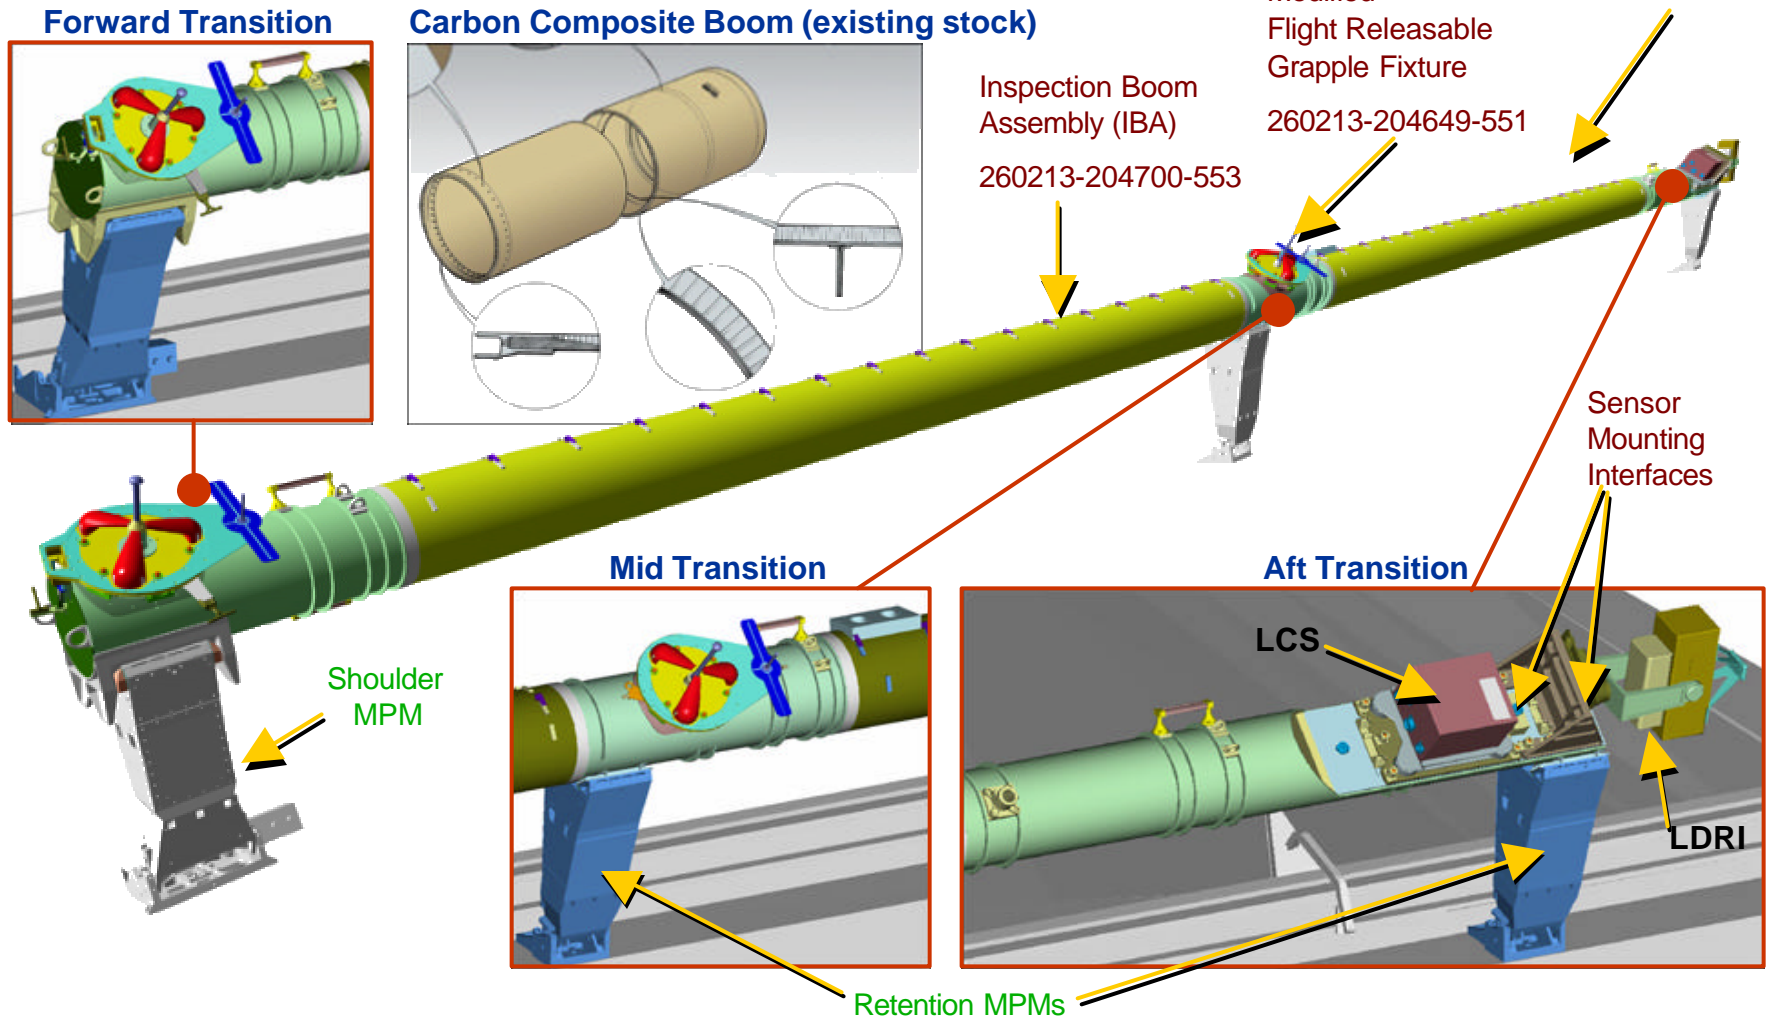
# Orbiter Boom Sensor System

- Mounted on Starboard sill of Orbiter bay

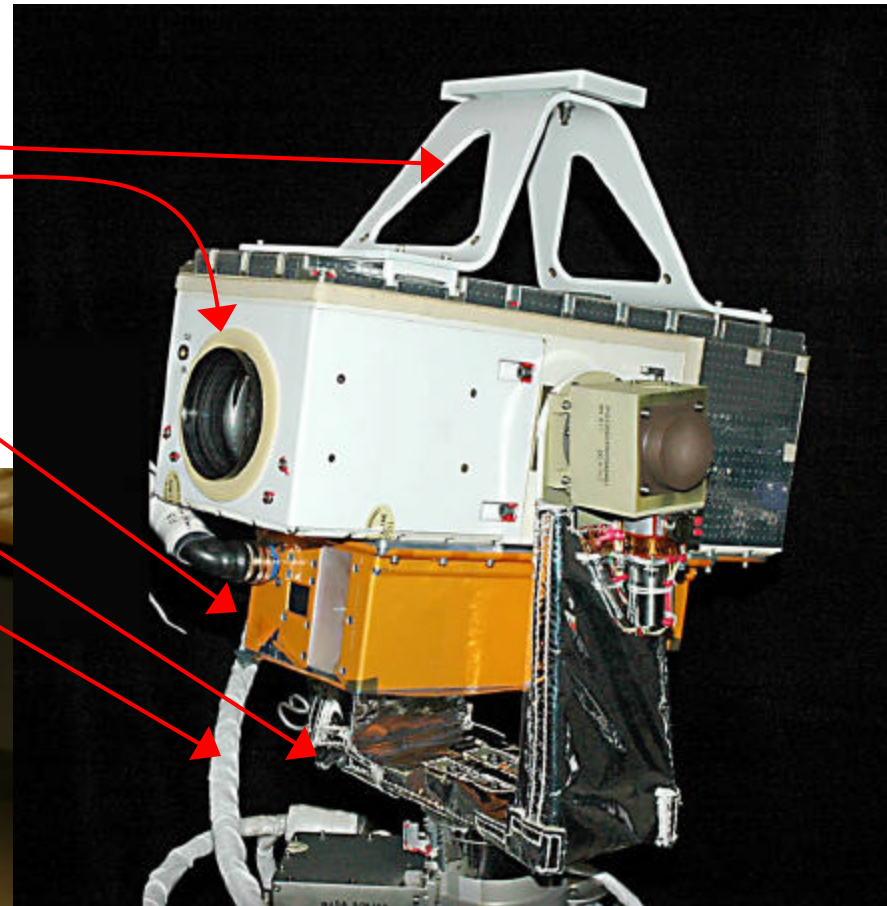
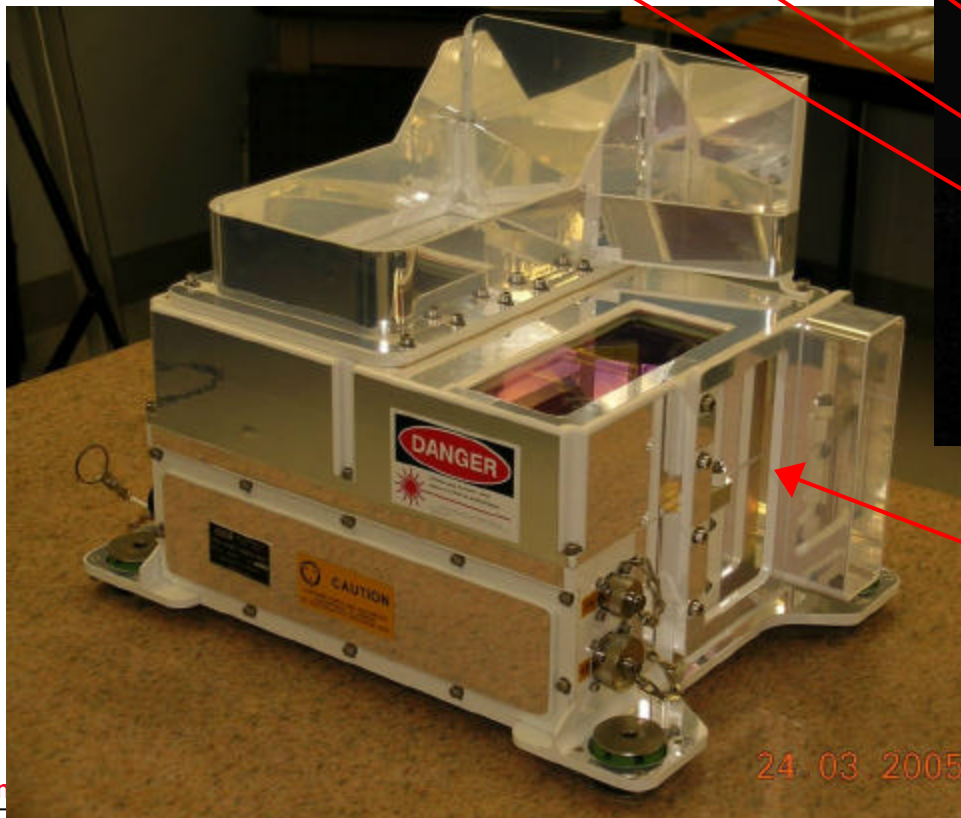
## Sensor Package 1

- Counterweight
- Intensified TV Camera
- LDRI – Laser Dynamic Range Imager
- PTU – Pan-Tilt Unit
- W 601 cable

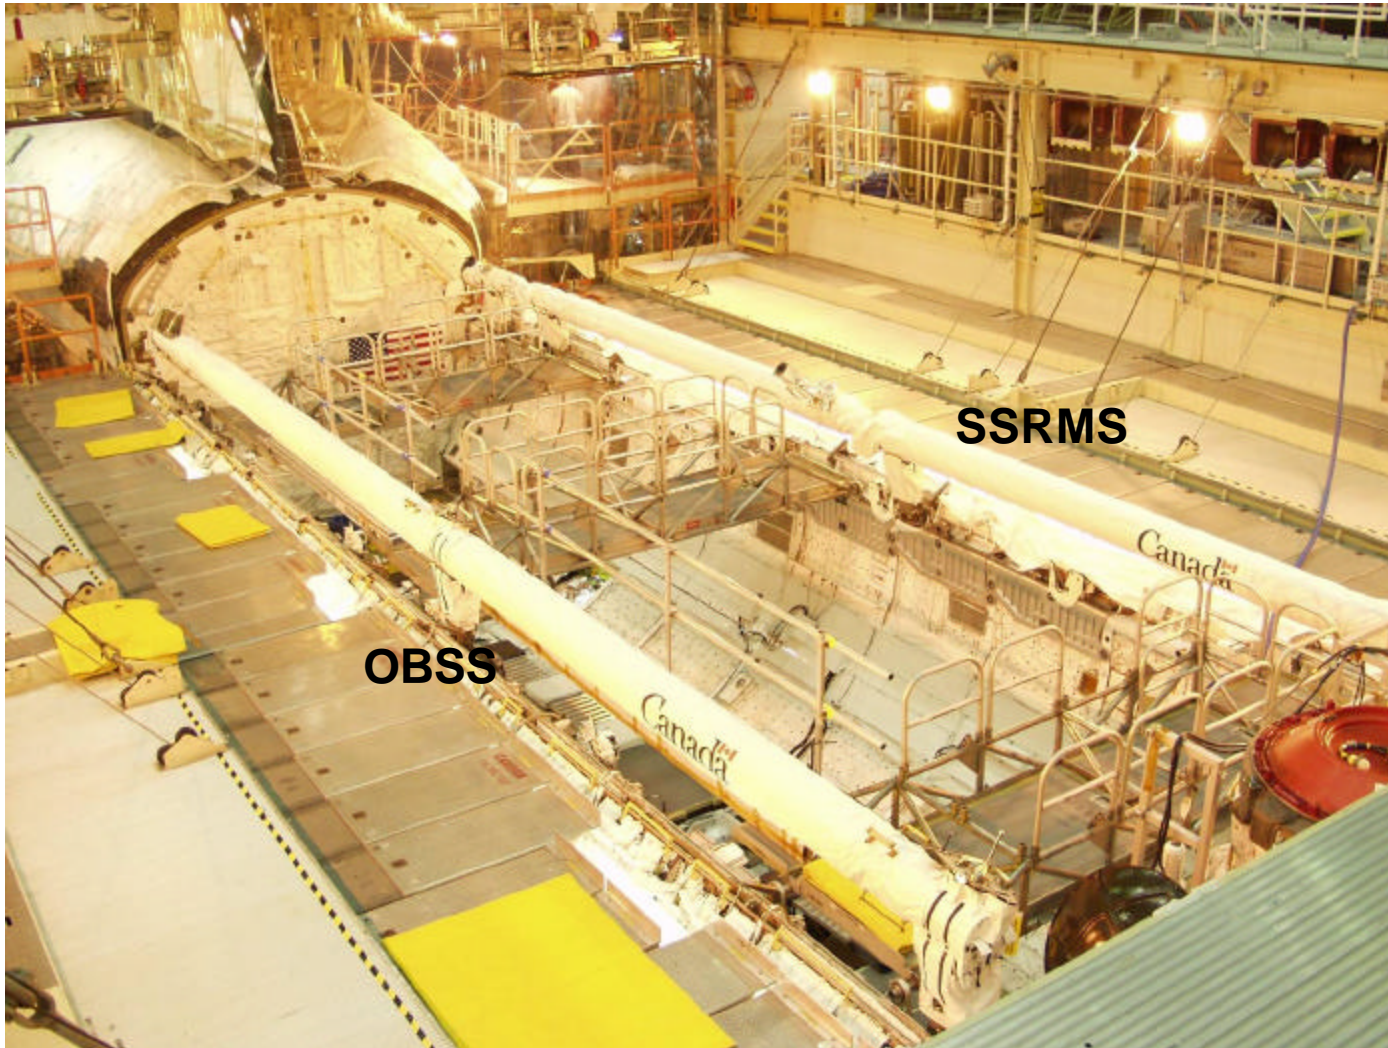
## Boom Installed in OV-103

- LCS – Laser Camera System
- W602 cable (not shown)
- Laptop cable (not shown)

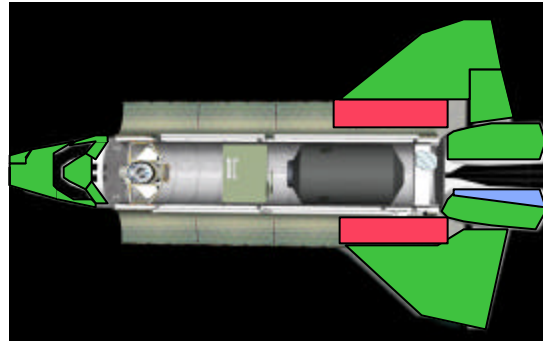
**Figure 1 – LDRI Tile Acreage Reach (Top View - Docked or Undocked)**

Reachable in all Sensor / Vehicle configurations
	Reachable with less than 5ft clearance
	Not accessible

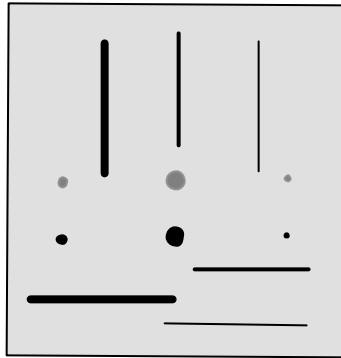
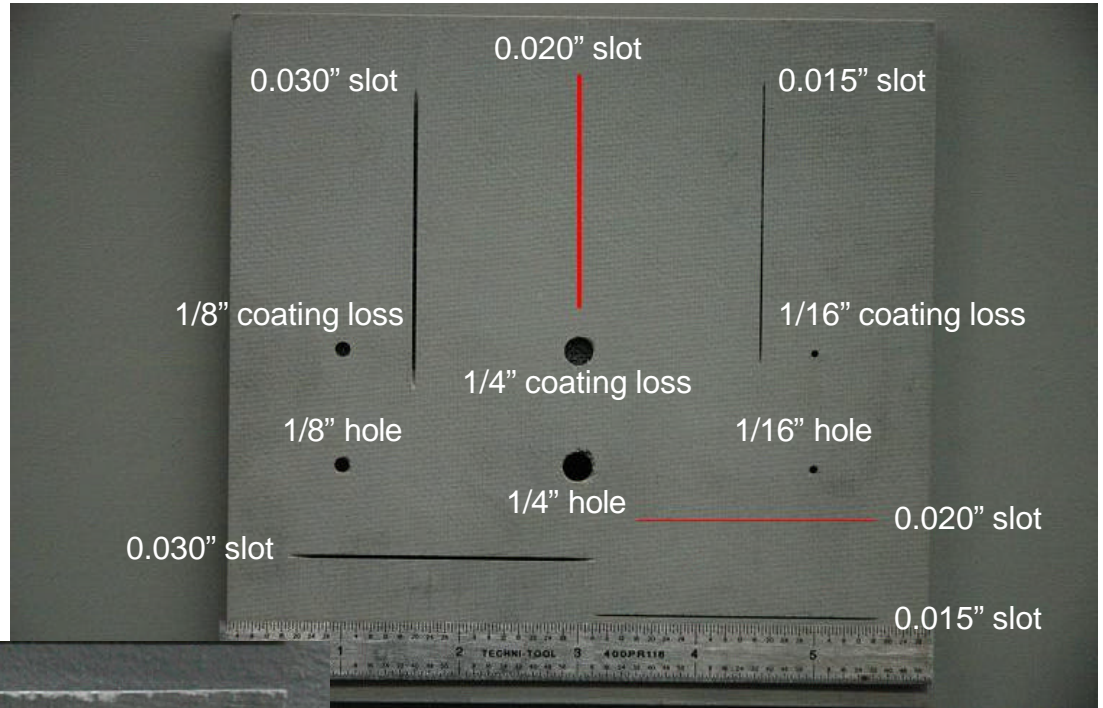
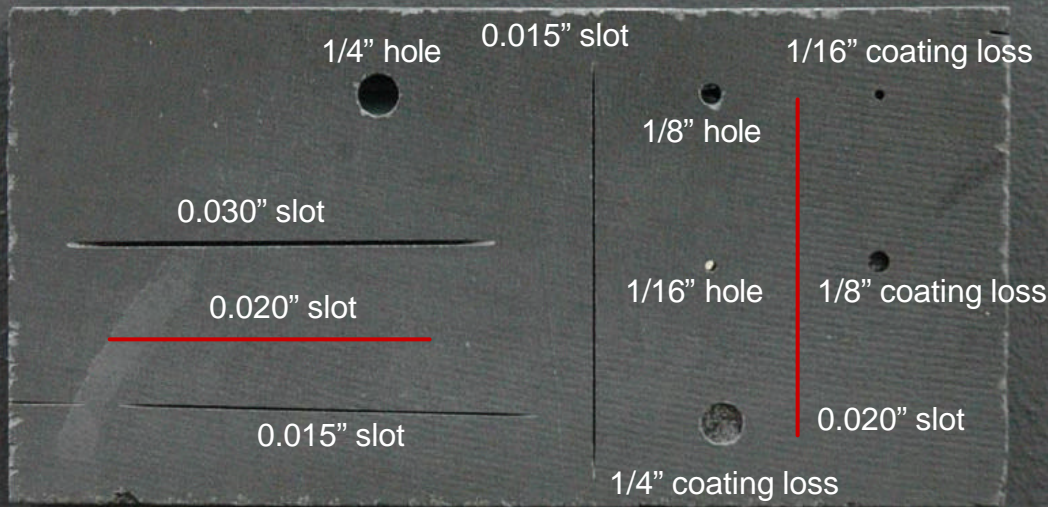
## Sample Description

- Unflown RCC
- Machined "damage"

- Flown RCC
- Machined "damage"

- Showed generally positive results when being used in a focused inspection for small RCC damage, including the following: 0.25", 0.125", & 0.0625" thru holes; 0.25", 0.125", & 0.0625" regions of exposed substrate, and 0.015" & 0.03" wide slots (.02" slots were not in RCC samples at time of testing)

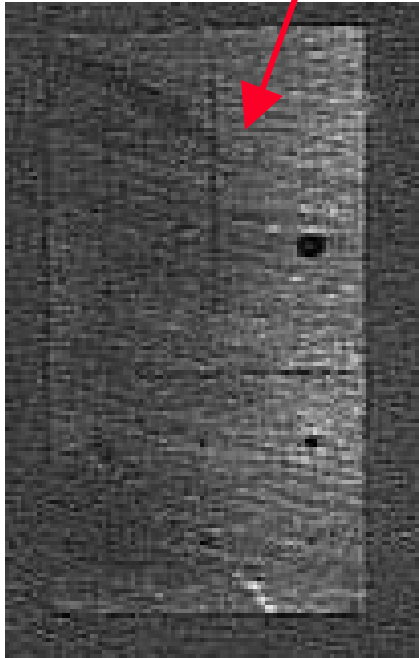
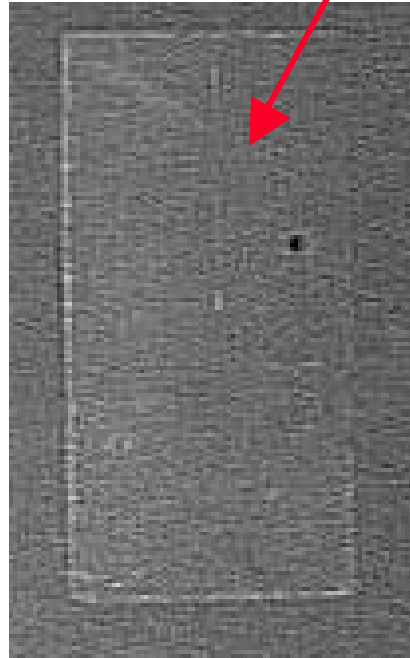
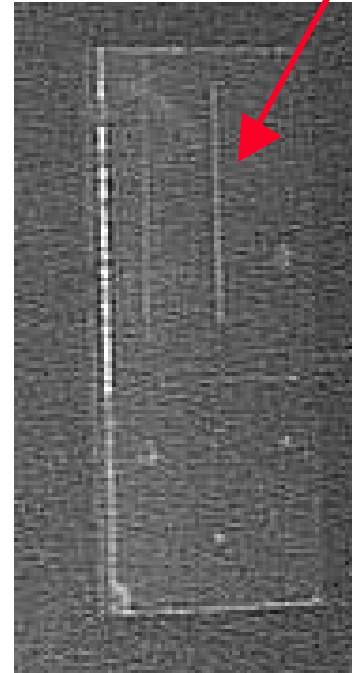
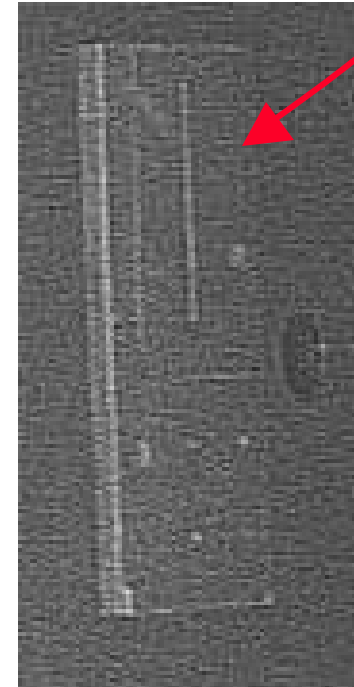
## LDRI Data – Flown Panel

45 Deg

65 Deg

- 1 m/min, 7 feet, No Sun

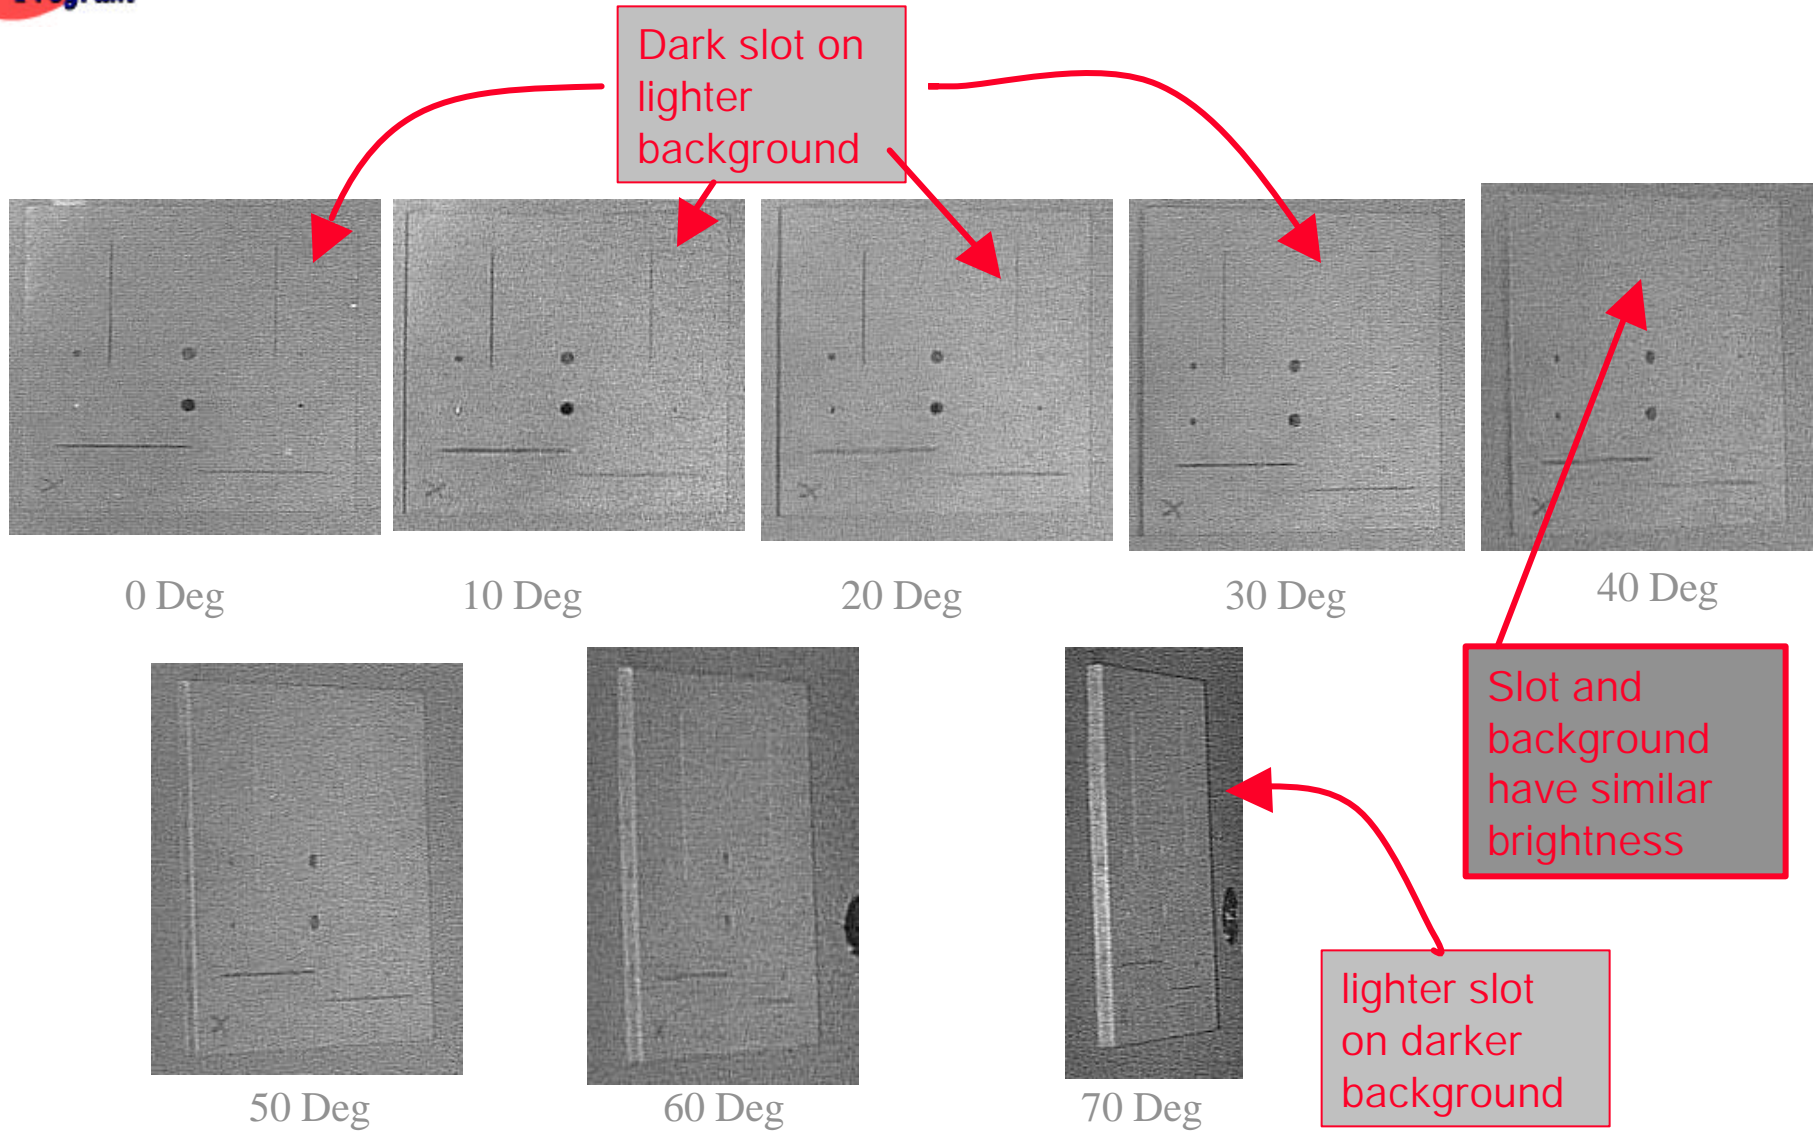
## LDRI Data – Unflown Panel

- **No Sun, un-flown RCC, 5 Feet, no motion**

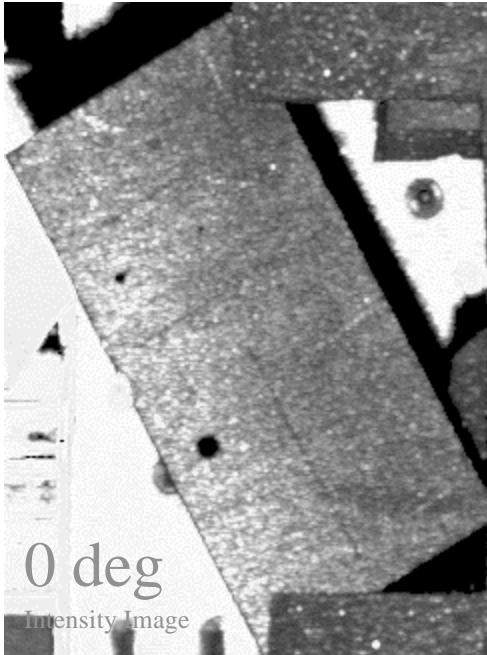
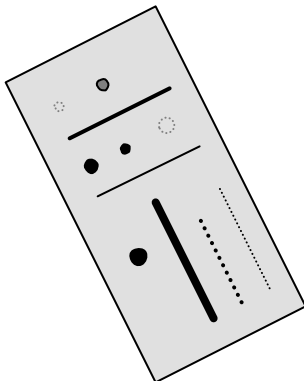
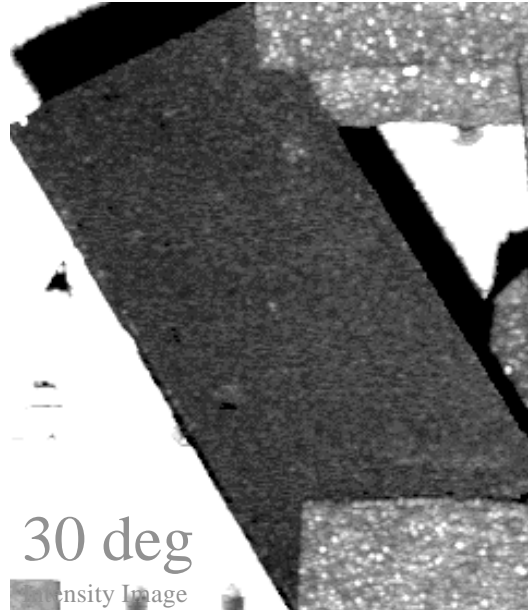
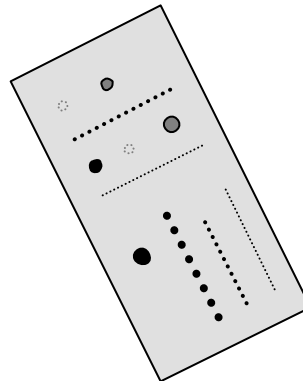
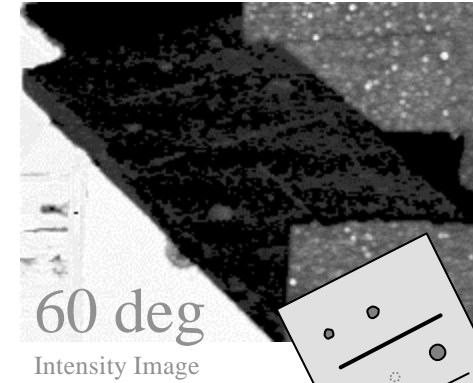
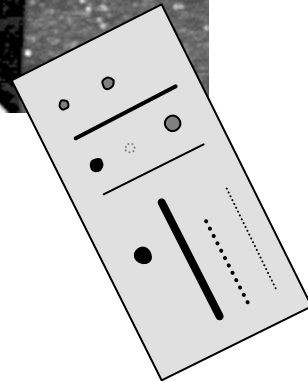
## LCS Data – Flown Panel

Range 7'  
Motion MP4  
FOV 15°  
Res. 1024

- Sensor Package 1, SP1, Inspection capabilities
  - Certified Levels
    - Detect ¼" through holes on RCC
    - Measure 3-D depth to +/- ¼"
  - Observed performance under some flight-like conditions

- Both sensors provide adequate resolution for 3D detection. If comparing sensors, SP1 is more robust in detecting surface damage and SP2 is more robust in measuring depth

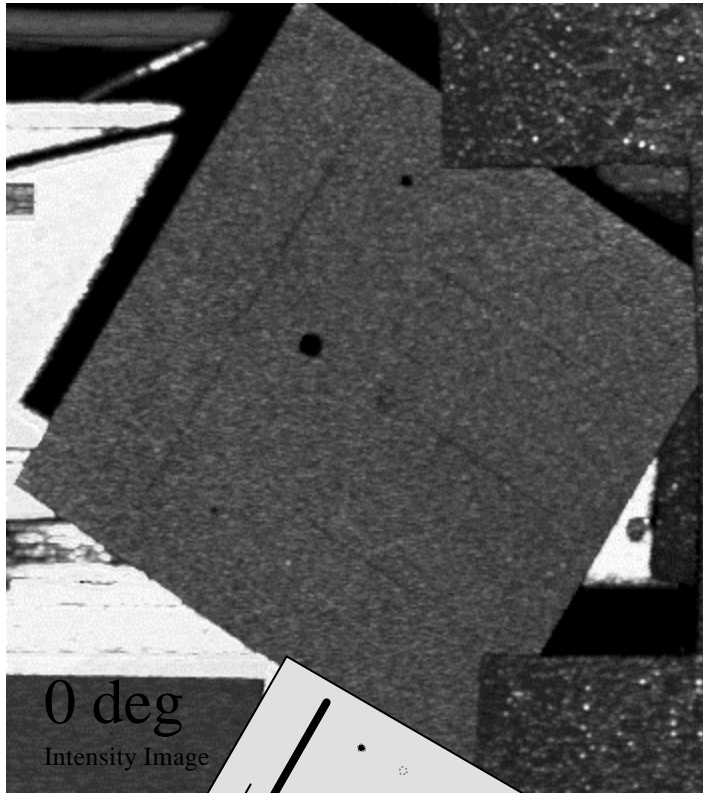
## LCS Data – Unflown Panel

Range 7'  
Motion MP4  
FOV 15°  
Res. 1024

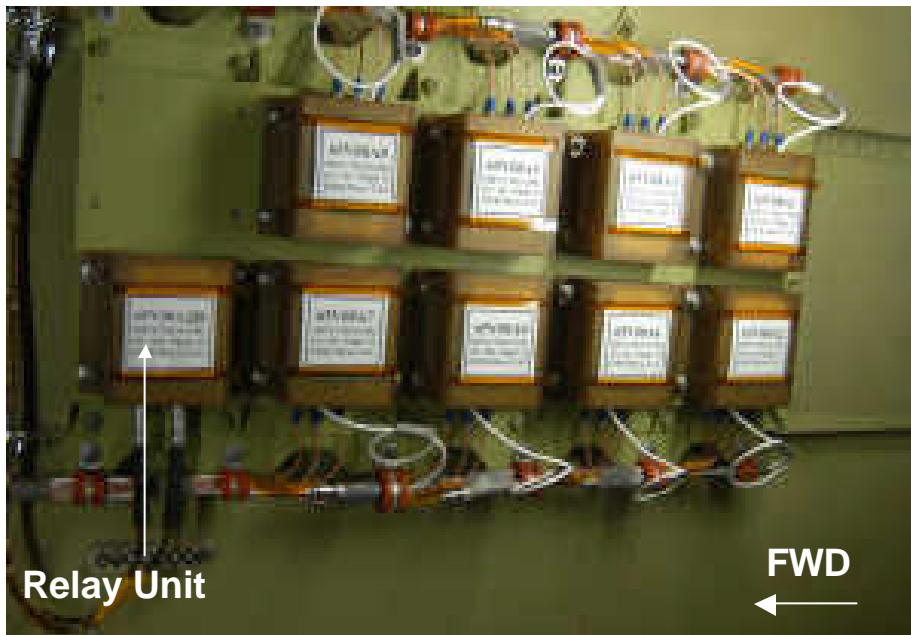
**Wing Glove**

- Sensor units and relay units mounted on interface plates using mechanical fasteners
- Interface plates are mounted to the wing structure using brackets and mechanical fasteners

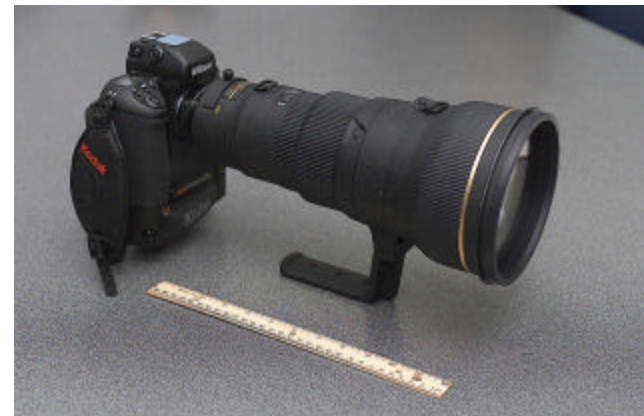
**DCS 760 with 400mm lens**

- Downlinkable, digital still imagery of the Space Shuttle upper and lower surfaces will be obtained during the docking approach R-bar Pitch Maneuver (RPM) at 600 feet
- Two ISS crewmen positioned at ISS Service Module windows and using Kodak Digital Camera System 760 (DCS 760) digital still cameras will obtain a series of still images of the thermal protection system (TPS) tiles and critical areas of the Orbiter
- One crewman will use a DCS 760 with a 400mm lens to acquire nine images covering the shuttle lower surface TPS
  - 2" analytical resolution @ 600 ft
- The other crewman will use a DCS 760 with a 400mm lens and 2X teleconverter to acquire twelve images covering critical areas around the shuttle landing gear doors, external tank doors and elevon coves
  - 1" analytical resolution @ 600 ft

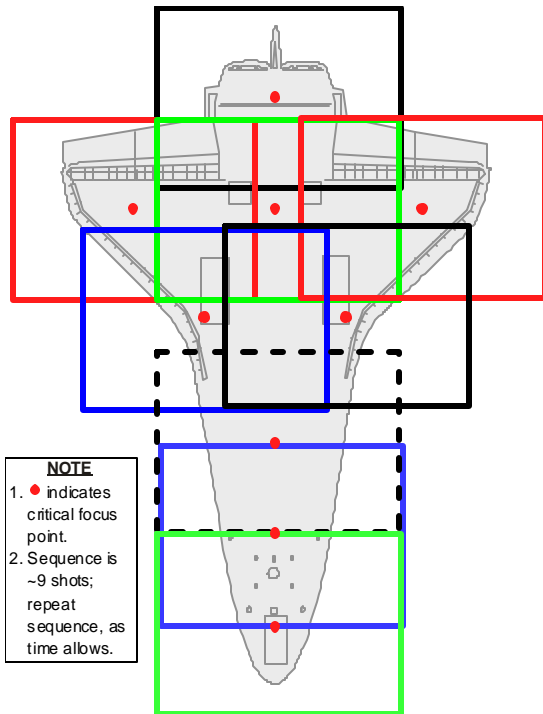
## 400mm lens photo mapping

**NOTE**  
1. ● indicates critical focus point.  
2. Sequence is ~9 shots; repeat sequence, as time allows.

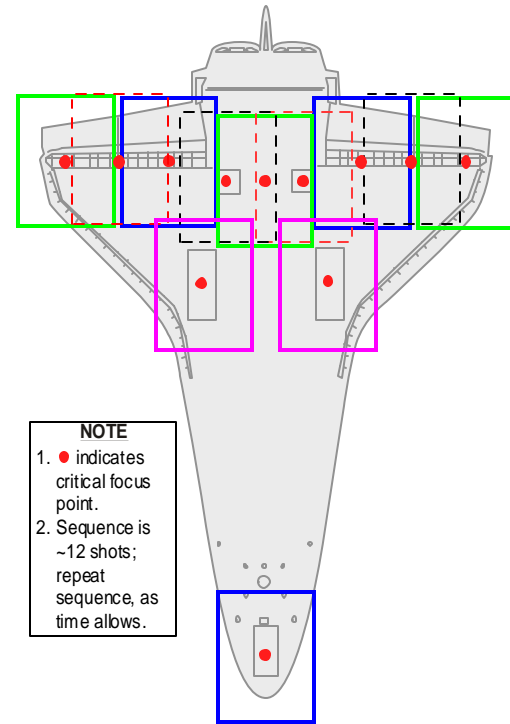
## 800mm lens photo mapping

**NOTE**  
1. ● indicates critical focus point.  
2. Sequence is ~12 shots; repeat sequence, as time allows.

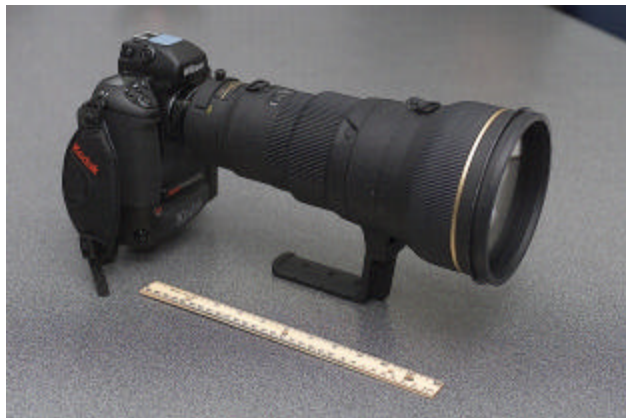
**DCS 760 with 400mm lens**

- Requirements: CAIB R3.4-2: Provide a capability to obtain and down link high-resolution images of the ET after it separates. Satisfied via:
  - Crew handheld digital still camera
  - Digital Umbilical Well Still Camera
- Crew handheld camera
  - Utilizing previously flown digital still camera (Kodak DCS 760) instead of previously used film camera (Nikon F5) with 400mm lens
    - Digital image files will be downlinked late in flight day 1
  - Orbiter post-ET sep maneuver changed to bring ET into view in overhead window about 2 minutes sooner (MECO +3 minutes) and 2500 ft closer (~2000 ft)
    - Analytical resolution ~8" at 2000 ft

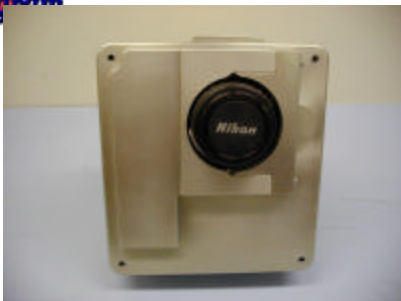
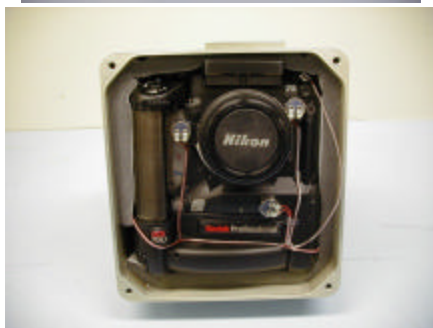
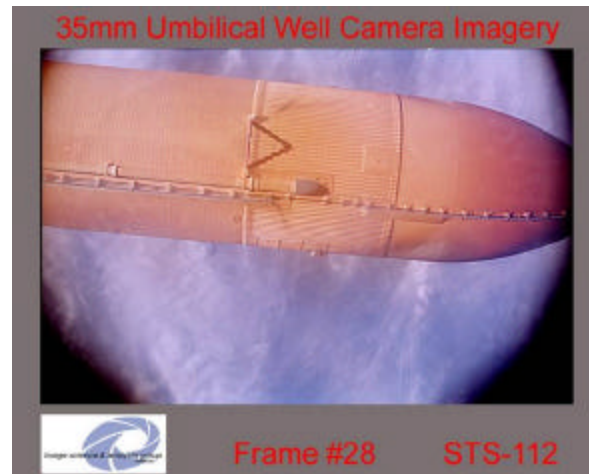
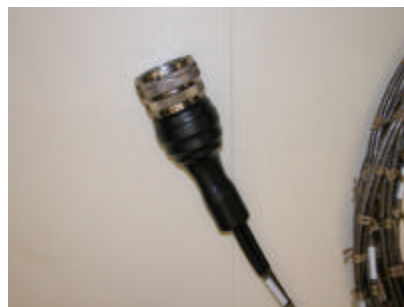
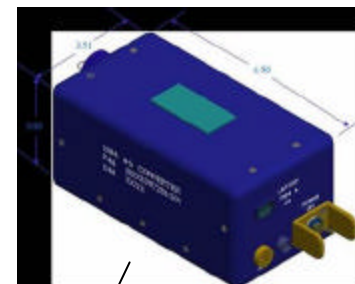
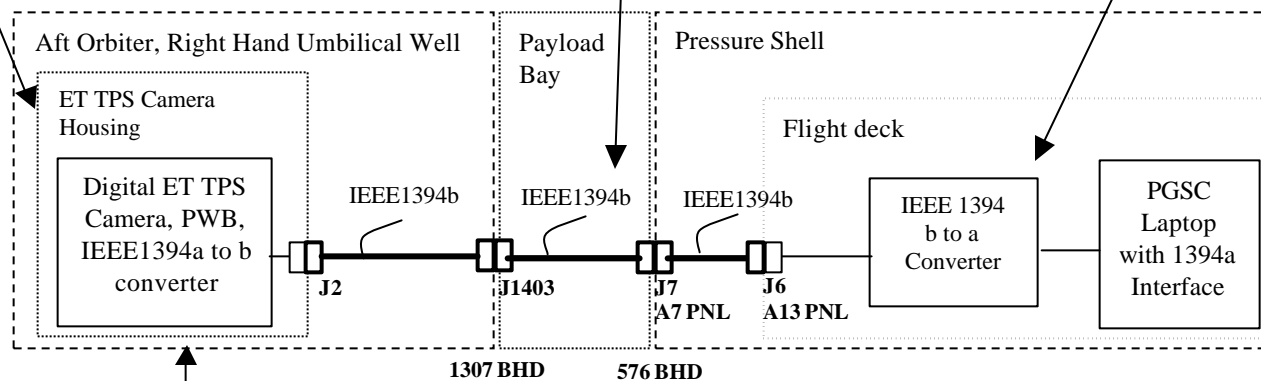
# Digital Umbilical Camera System

- Digital Umbilical Well Still Camera Overview
  - Digital Camera System replaces the 35mm film camera in the right-hand Orbiter umbilical well
  - System components:
